Navajo Abandoned Uranium Mine

Site Screen Report

Yazzie No. 1 AUM Site

January 2011

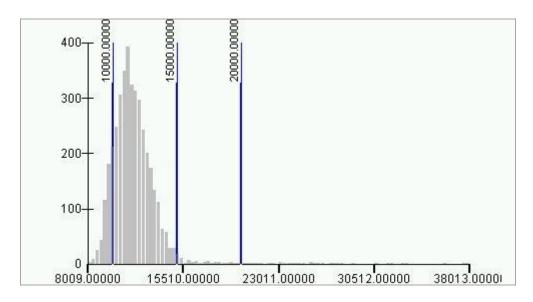
Distribution Chart and Statistics:

A total of 2,452 gamma radiation measurements were collected from the mine site, ranging from 8,167 cpm to 63,576 cpm. The measurements collected at the reclamation cap were found at a maximum level of approximately 65,000 cpm. The measurements are represented in Figures 1 and 2.

The following chart and statistics were generated by ESRI ArcGIS 9.3.1, and show the general distribution of the site gamma radiation measurements. The horizontal X axis represents the gamma radiation reading levels in cpm (lowest levels to the left). The vertical Y axis represents the frequency of each gamma radiation level.

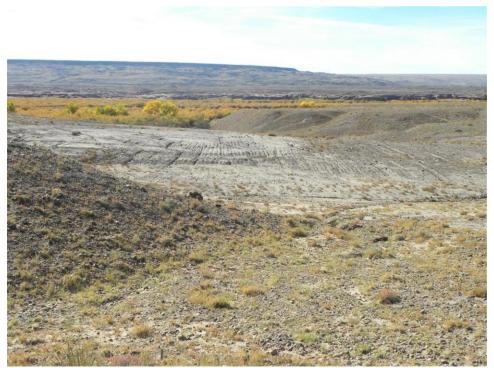
Large reclamation cap stretching downgradient, fine grey material, moderate cuts due to erosion

Photo 1. Yazzie No. 1 mine site

Photo 2. Yazzie No. 1 mine site

Photo 3. Yazzie No. 1 mine site
